REPORT OF INVESTIGATION

Fatal Fall of Roof Accident
August 3, 2005

Mine No. 1
Stillhouse Mining LLC
Cumberland, Harlan, Kentucky
ID No. 15-17165

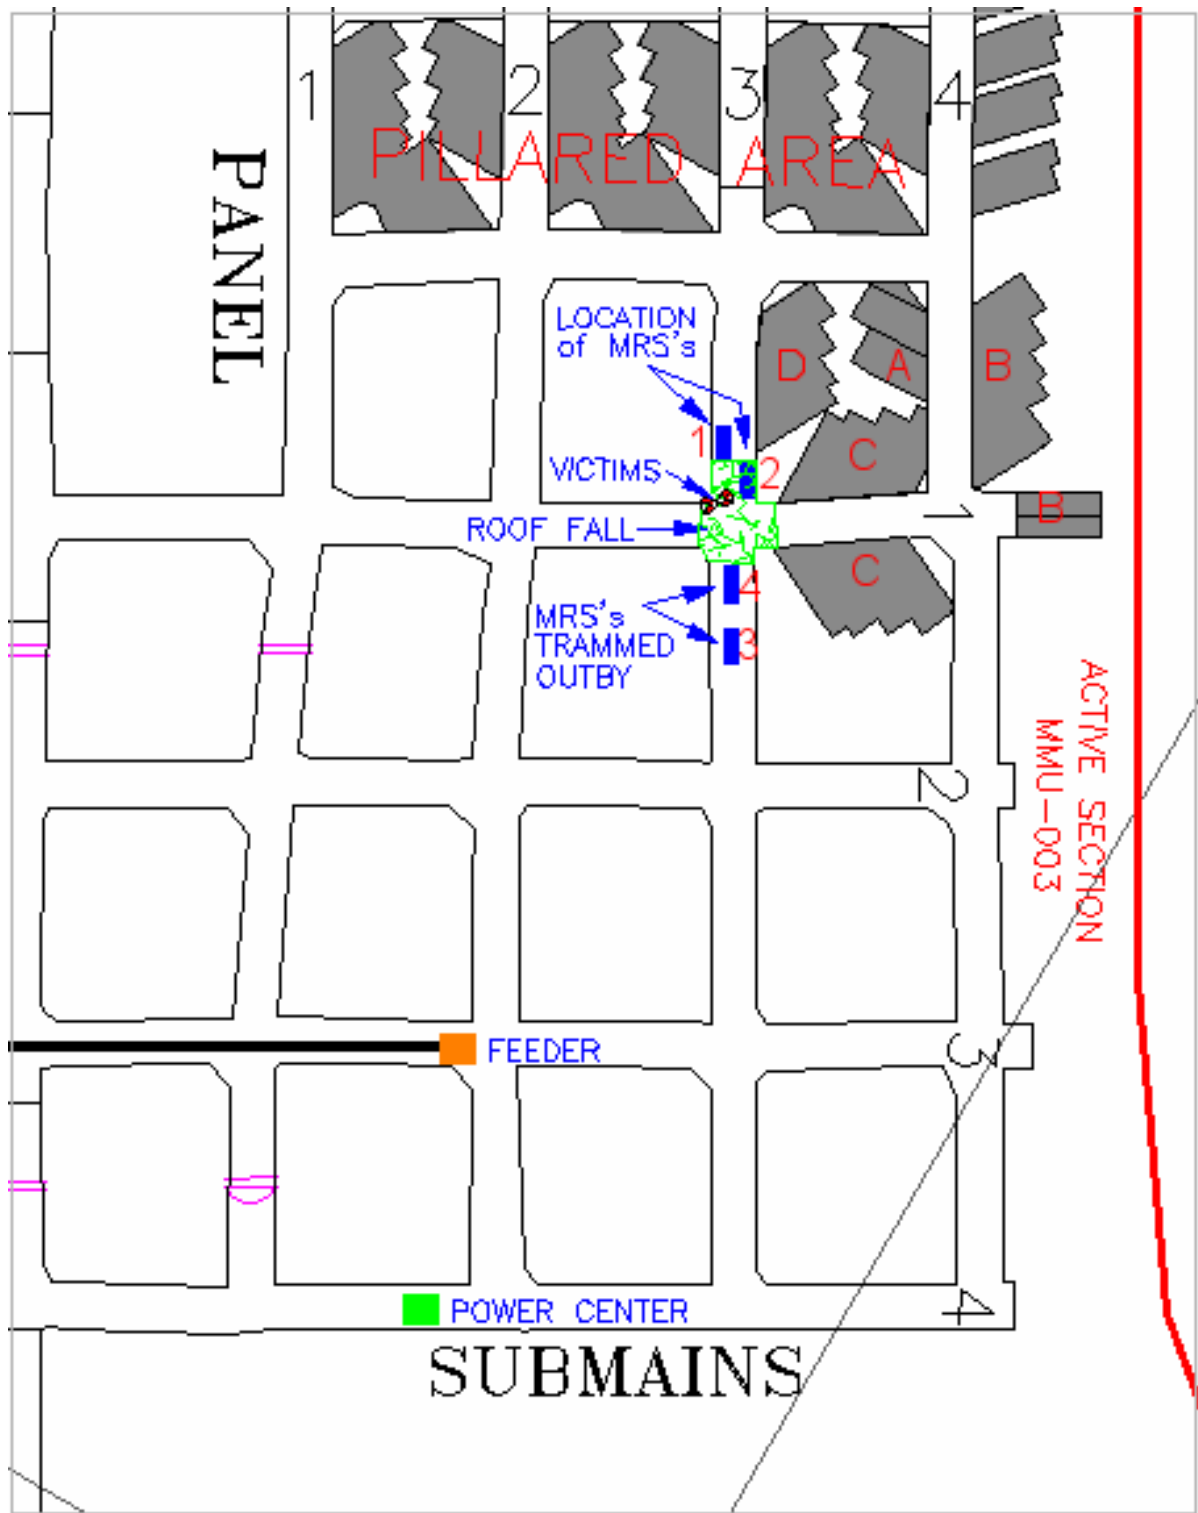
ACCIDENT SITE

At this time, 9:30 p.m., Cole and Wilder were standing beside the No. 2 MRS, with Cole at the manual controls, when the mine roof fell. The fall extended from the front of the No. 1 MRS, through the intersection, and 13 feet into the crosscut to the back of the No. 4 MRS. Gross looked toward Cole and Wilder as the MRS lights disappeared beneath the falling rock.

The approved Roof Control Plan required MRS units to be moved sequentially in pairs so that each unit would not be offset more than one half unit length from its companion unit. However, this provision was not being complied with at the time of the accident. To comply with the plan, the No. 2 MRS should not have been moved past the No. 1 MRS and the Nos. 3 and 4 MRS units should have remained set until the Nos. 1 and 2 MRS units were brought forward into the intersection. Also, the MRS operators were not in a remote location while moving the MRS units, they were in the intersection. This exposed Cole and Wilder to hazards associated with inadequately supported roof immediately adjacent to the incorrectly positioned MRS units and faulty cut sequence.
